REPORT 79-16

Construction and performance of membrane encapsulated soil layers in Alaska

Prepared for
DIRECTORATE OF MILITARY PROGRAMS
OFFICE, CHIEF OF ENGINEERS
By
UNITED STATES ARMY
CORPS OF ENGINEERS
COLD REGIONS RESEARCH AND ENGINEERING LABORATORY
HANOVER, NEW HAMPSHIRE, U.S.A.

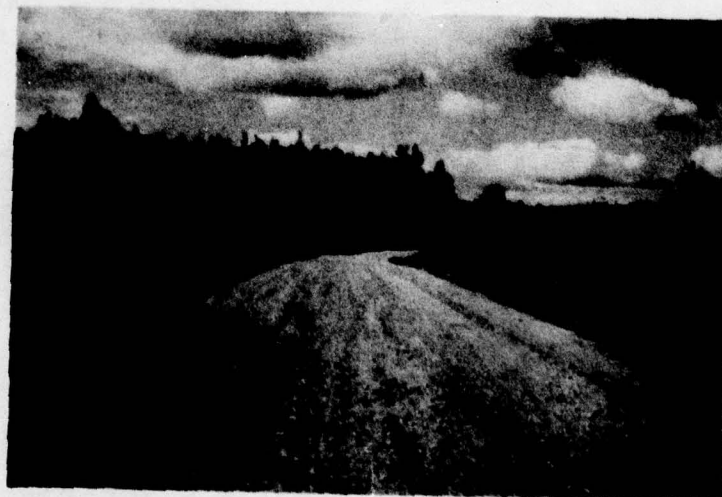
Figure 23. Completed MESL section, Elmendorf AFB.

About 2 in. (51 mm) of clean sand was spread as a blotting and cushioning layer on the emulsion-coated top membrane before placing a 6 to 8-in. (0.15 to 0.20-m) gravel wearing surface of the previously excavated and stockpiled roadbed material. Final grading and compacting of the gravel surface with a road grader and the wobbly-wheeled roller were accomplished after the shoulders of the road and parallel drainage ditches were shaped and graded. The finished road is shown in Figure 23.

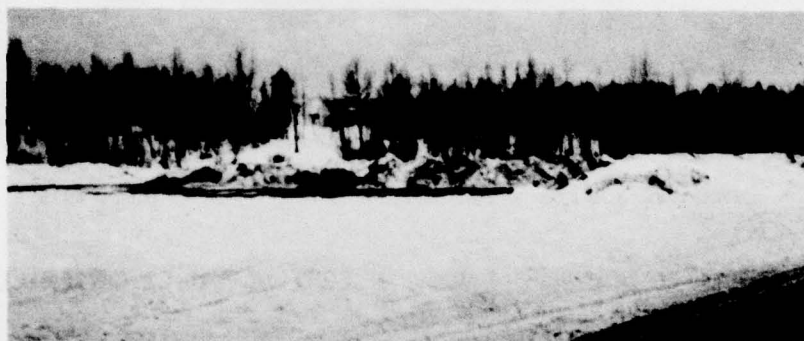
Figure 30. Snow dump adjacent to Elmendorf AFB MESL.

several thousand passes of mixed vehicular traffic were made over the road. During the winter-time the dump trucks hauling sand for sanding the streets and parking lots on the base use the road. However, the more critical loading periods are during and after spring thaw. The open area adjacent to the road is used as a snow dump during snow removal operations on the base throughout the winter (Fig. 30). This results in considerable water ponding in the parallel ditches and on the road surface during spring breakup (Fig. 31). Figure 32, a photograph taken during the soil coring operation of March 1975, shows a typical closeup of the surface spring meltwater conditions.

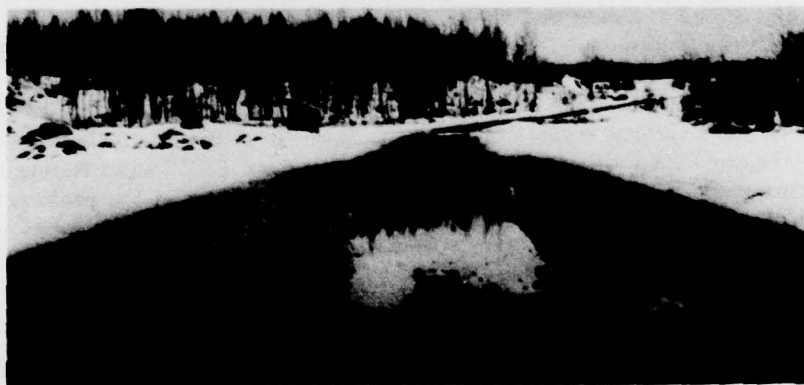
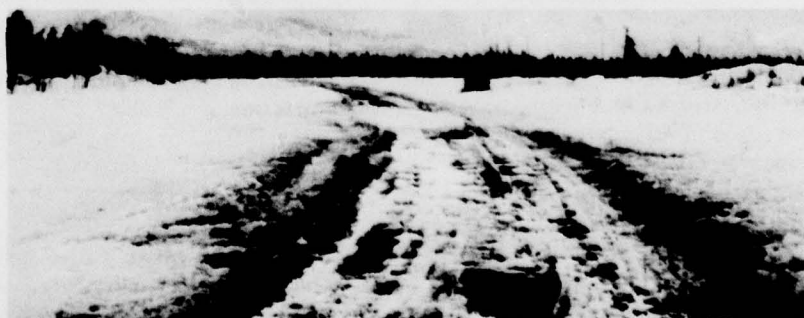
Figure 31. Ponding snowmelt on Elmendorf AFB MESL (north view, upper; south view, lower).

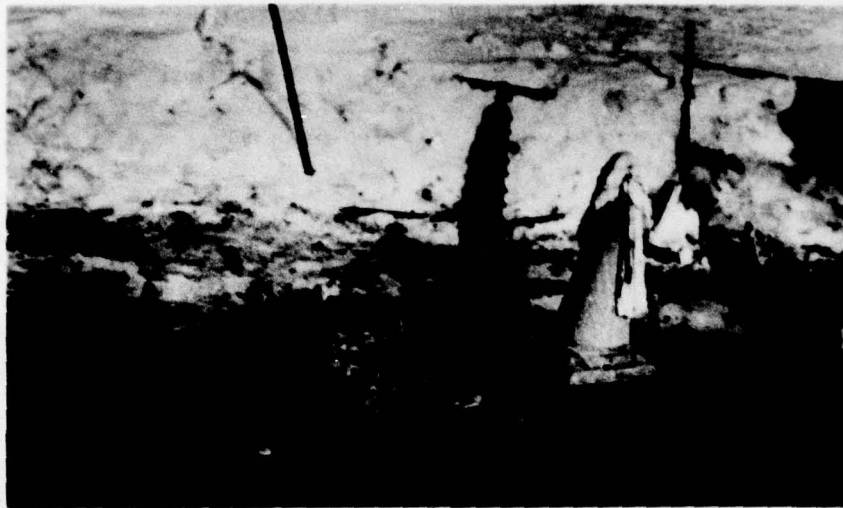
Figure 32. Soil core sampling, Elmendorf AFB MESL, March 1975.

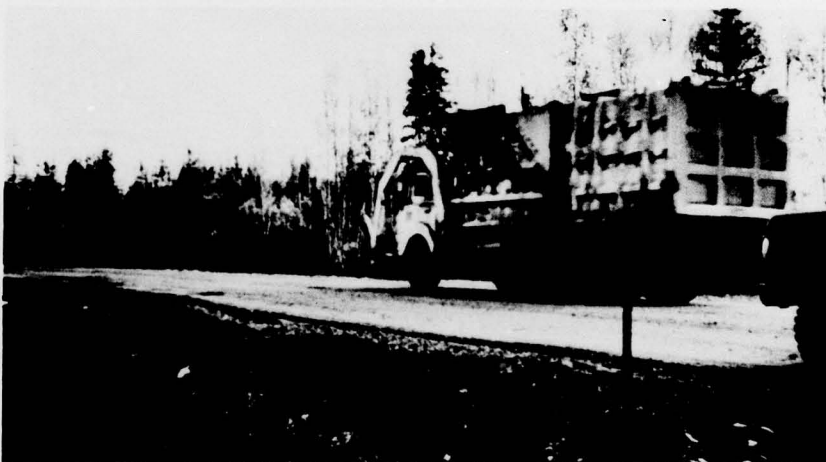
b. Dumpster truck.

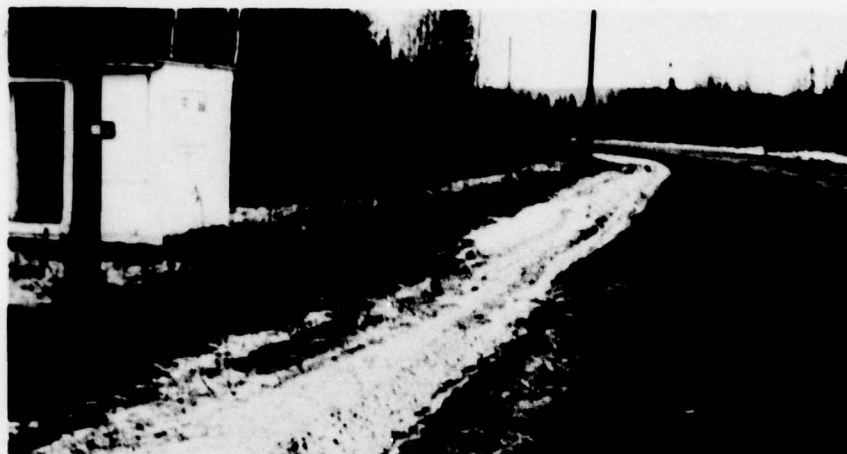
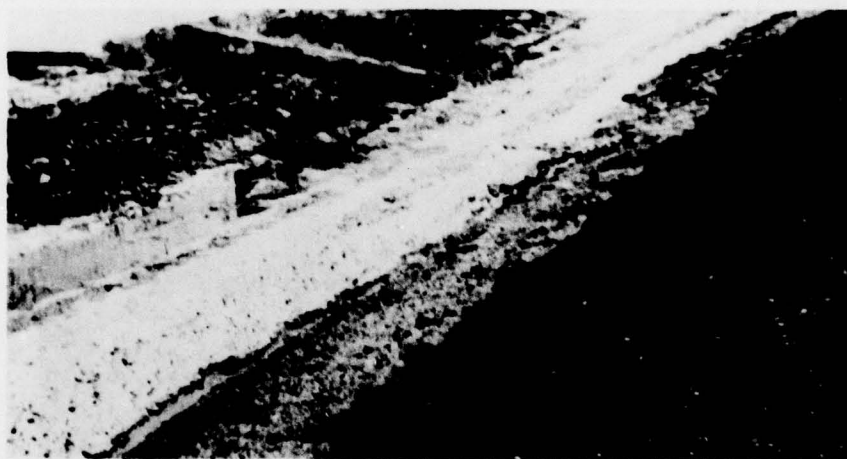
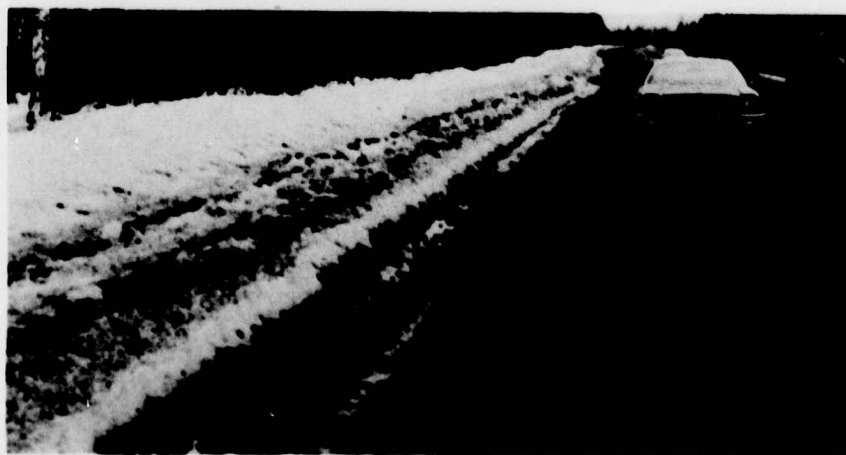
a. Left parallel ditch.

b. Close-up of left parallel ditch.

c. Right parallel ditch.

Figure 34. Snowmelt, Ft. Wainwright MESL, April 1977.

This MESL section is located in a gravel road used daily by dumpster and garbage trucks. During the wintertime the road is heavily trafficked by passenger cars driven to and from the Birch Hill Ski Area. Since construction of the MESL, the Army has used the road as a haul road for construction equipment and as an access road to the sanitary landfill; Alyeska Pipeline Service Company also has used it to move pipe and equipment for pipeline construction (Fig. 33). The road surface has been sprayed with used engine oil to stabilize the river gravel and control dust. Springtime snowmelt conditions (Fig. 34) are not nearly as severe on this section as on the Elmendorf AFB section.
